Ordered Removal of Southern/ABC Wheels

Todd Snyder – Dir Adv Frt Car Engr – former Chairman AAR/WABL

September 17, 2009 – Chicago – MARTS Technical Conference

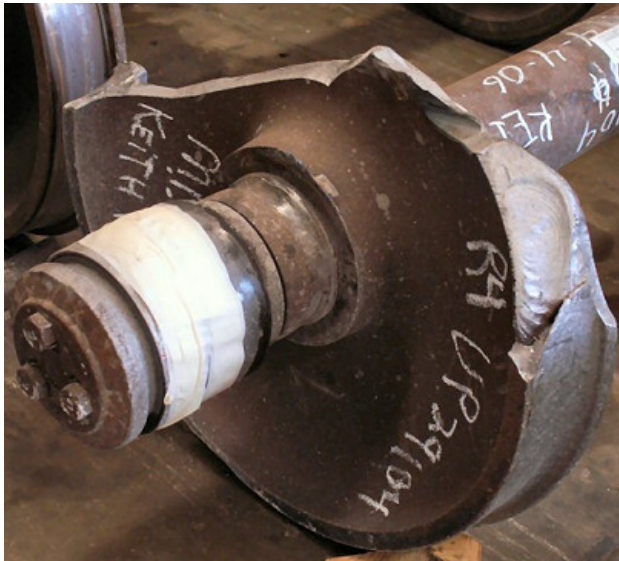
- **Hydrogen Cracking Believed to be Cause**
 - Small chance of a non-destructive testing solution
- **2-5 times as many broken wheels as other Mfgs**
 - RR Specific, Normalized
- **Higher Percentage Result in Expensive Derailments**
 - Catastrophic Failures versus Carman Found Broken Wheels
